## What is Milesight FusionXpert Technology?

Milesight FusionXpert Technology powers the Milesight Al Dual-sensor 180° Panoramic Camera, providing the seamless stitched 180° panorama. Seamlessly stitching images from two cameras, it delivers a true-to-life picture with no color or brightness discrepancies, and zero distortion. Experience a seamlessly stitched image that appears as if it was always one cohesive whole.

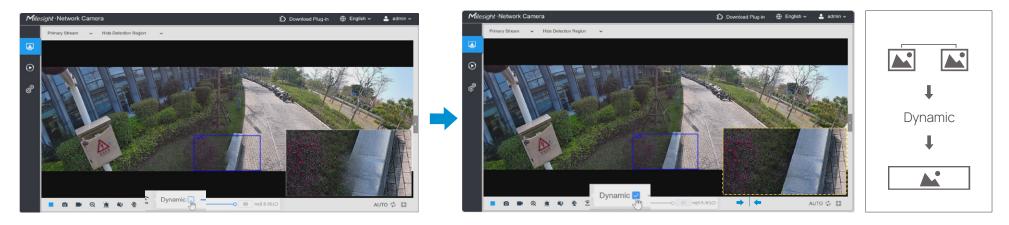
### **Dynamic Stitching**

In complex environments—especially in busy scenes with multiple moving targets—Milesight leverages advanced dynamic stitching technology to intelligently adapt to both subject and camera motion. This real-time processing ensures that dual-lens inputs are continuously and accurately stitched together, maintaining a seamless panoramic image without visual breaks or distortions.

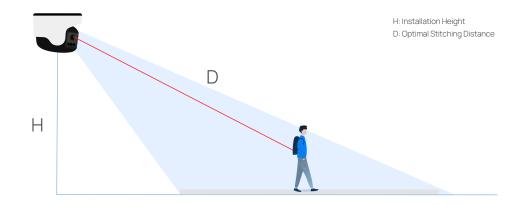
## **Optimal Stitching**

It allows users to manually set an optimal stitching distance—the specific range between the camera and the target scene—where the two lenses achieve the most accurate alignment. At this distance, the captured images merge perfectly into a unified, coherent panoramic view with no visible seams.

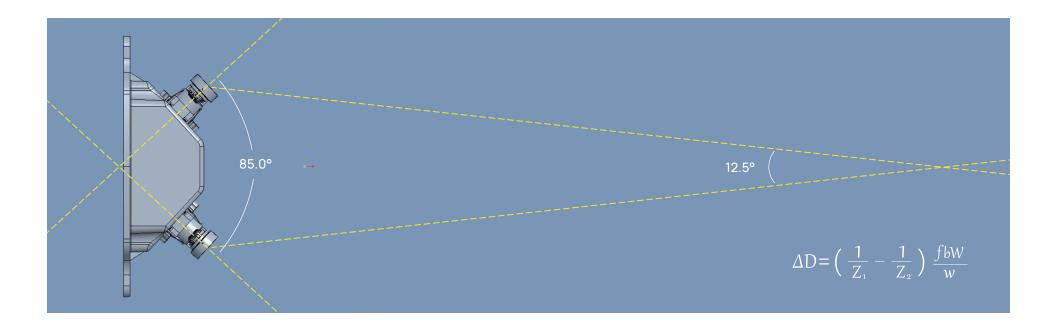
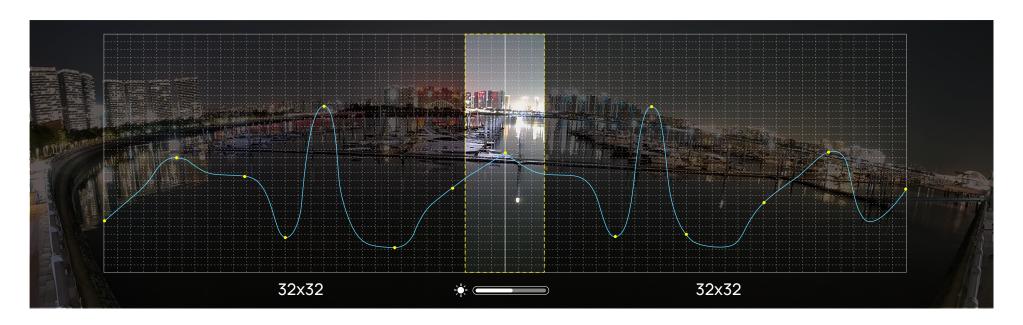
#### Golden 12.5° & Computational Model Solve Edge Distortions

Edge distortions are indeed a significant concern in single-lens panoramic cameras, often resulting in the loss of crucial information during surveillance. However, it is greatly solved with Milesight FusionXpert technology. The Image distortions stemming from spatial disparities between the two cameras are effectively addressed by the "Golden 12.5°" principle. This principle not only ensures a 180° field of view but also maximizes structural adjustments to minimize the impact of parallax.

Additionally, on the software side, to accommodate various installation requirements and ensure undistorted image effects at distances ranging from 0.5 to 30 meters, we have introduced a computational model function for distortion correction. This function resolves issues such as misalignment or ghosting in the stitching fusion zone and can automatically adjust parameters based on the environment, achieving seamless stitching at the geometric level.

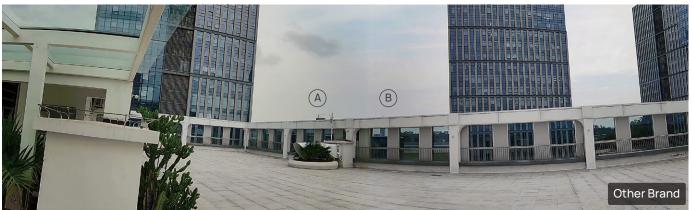
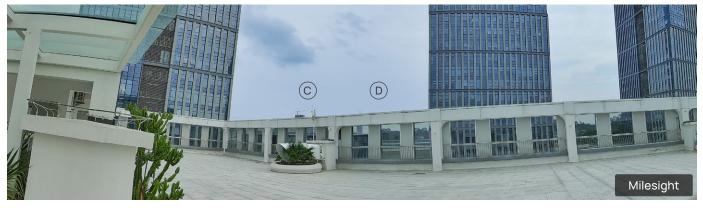
### Advanced Algorithms Ensuring Brightness Uniformity

The challenge of maintaining brightness uniformity across the panoramic image is tackled through advanced algorithms and chip-level innovations. Acknowledging the inherent variations in light sensitivity among lenses, Milesight's R&D team explored both algorithmic and hardware solutions. By partitioning the image with 32x32 Mesh Shading algorithm and analyzing the luminance values for each cell, the algorithm extracts, calculates, and integrates light presentation, ensuring consistent brightness across both cameras.
